Migdal – 2015

Marcela Zapata-Meza and Andrea Garza Díaz-Barriga

30/11/2017
Preliminary Report

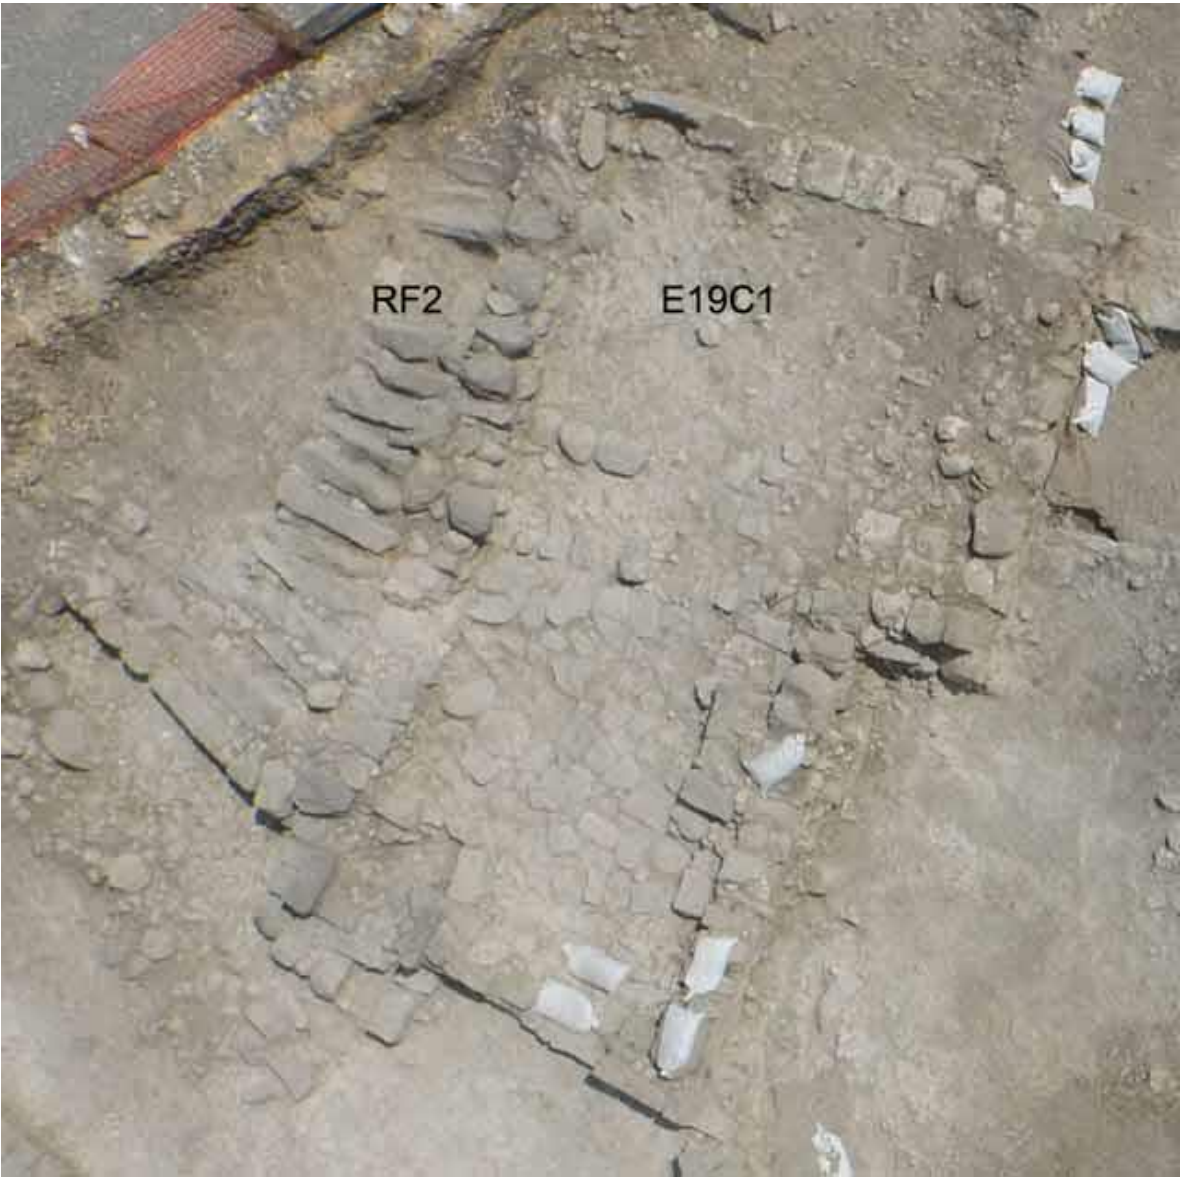
[6. Building E19C1 and the basalt slabs along W212, looking northeast.](#)

Building E19C1 (Fig. 6) is a rectangular building, which appears—judging by its orientation—to be the continuation of the market in Area E. The building is also connected with Area A with a wall extending to the south (W65). An entrance set in its western wall allowed access from Street 8, but it was later blocked. A row of eleven long basalt slabs (RF2) found along the outside face of its northern wall (W212), seem to have been roof beams of some structure, possibly of a small purification bath (*miqveh*) similar to the ones discovered in past seasons.

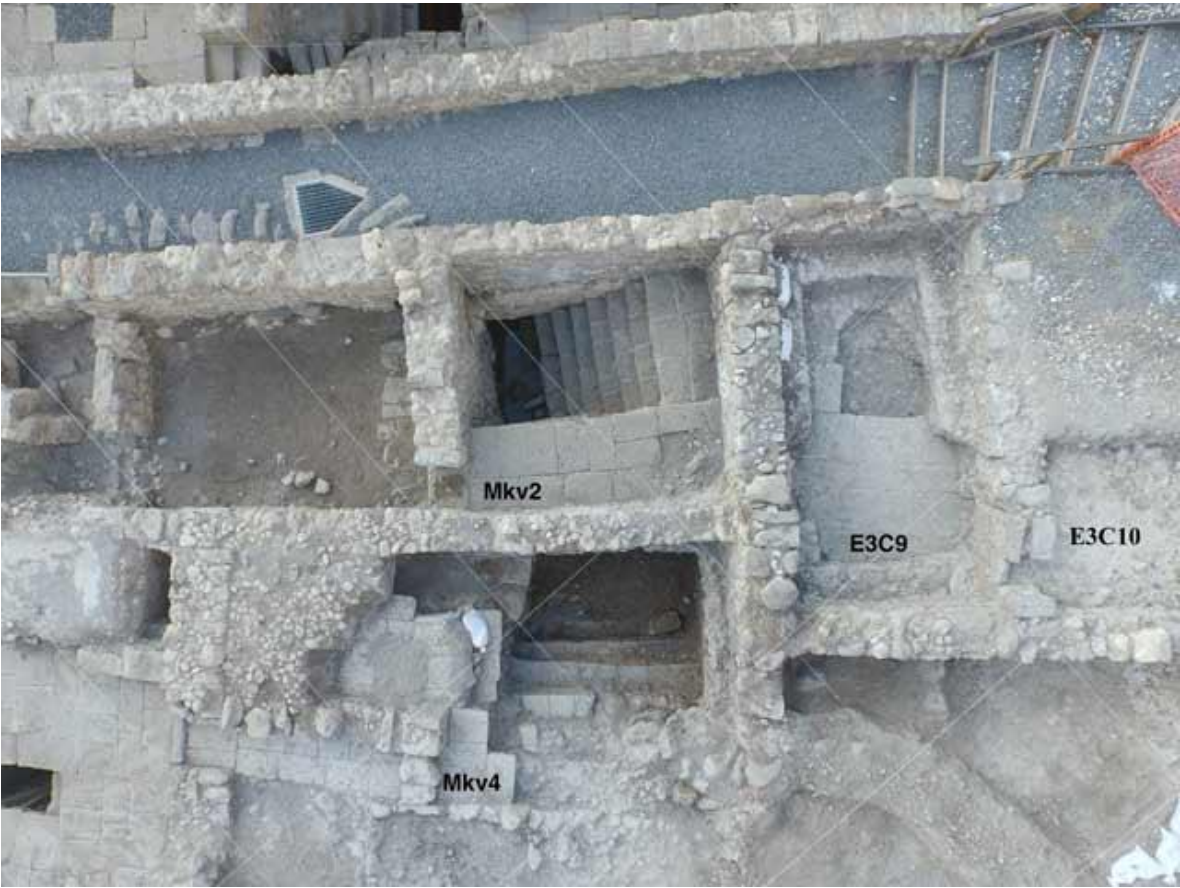
[7. Room E3C9 and Ritual Baths Mkv2 and Mkv4, looking south.](#)

Room E3C9 (Fig. 7) has a perfectly cut and assembled floor of basalt pavers, with benches along the four walls. Traces of white plaster were found on several sections of the walls. Two possible windows were identified in the east and the west walls

(W42, W217); the one in W42, which separates the room from Ritual Bath Mkv2, was blocked.

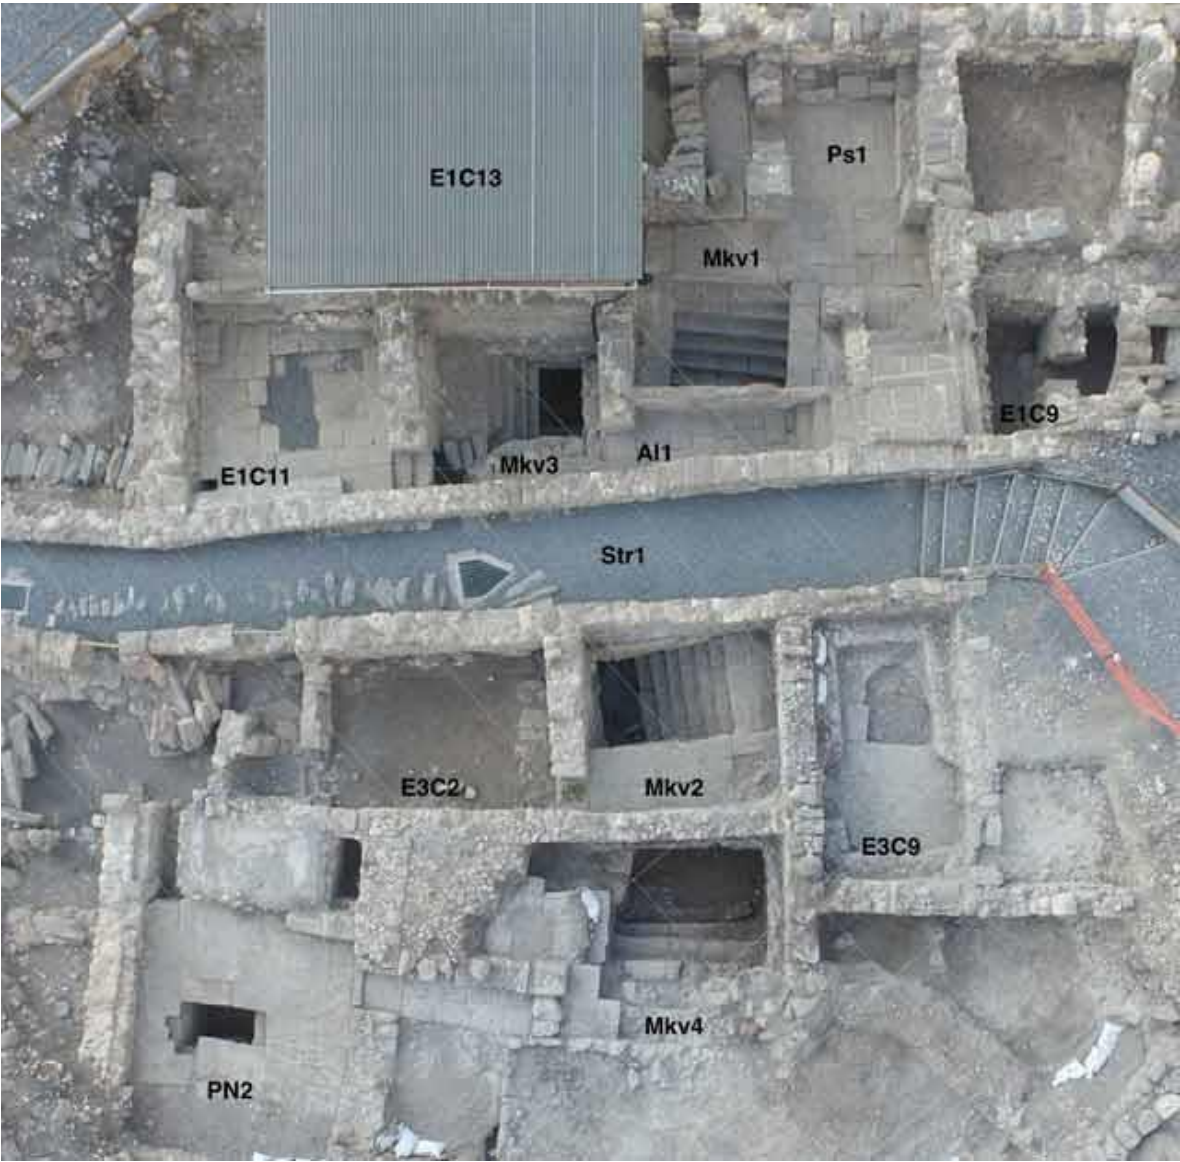
[8. The two pairs of Ritual Baths in Areas A and F, looking south.](#)

Ritual Bath (*Miqveh*) Mkv4. This ritual purification bath is the fourth discovered at Migdal, and together with Bath Mkv2 it forms a double ritual bath, as do Baths Mkv1 and Mkv3 in Area A. The two baths in each of these pairs are separated by a wall, with a channel running through it to allow the circulation of water (Fig. 8). Furthermore, this bath has the same architectural traits as the other three: it was constructed of well-dressed basalt blocks, has seven steps and was treated with white plaster, some of which is still found on the upper parts of the walls. Like the other baths, this one also utilized the natural water table of the Sea of Galilee. With their floor dug down to an elevation of c. 208 m below sea level—approximately 2 m below the elevation of floors of the surrounding buildings—water that seeps through the cracks in the floor and the lower steps feeds the four baths. The water circulates through the channel system under Street 1 back into the lake. This bath, like the other three, also received water from the Mount Arbel and Naḥal Arbel (Wadi el-Ḥamam) springs. Unlike the other baths, this one shows evidence of destruction: the two upper steps are not complete, and numerous stones were scattered throughout its upper levels. Also, it was not sealed with soil fills containing pottery fragments as did the other baths.

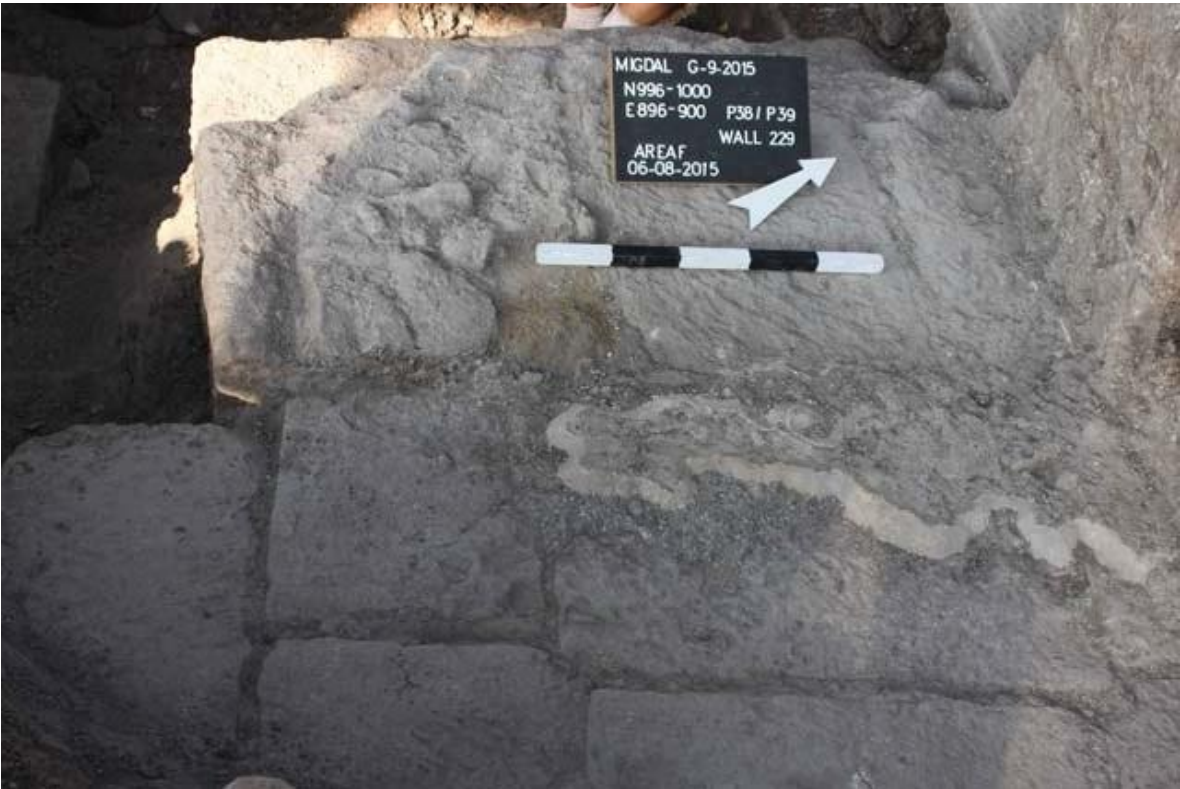
[9. A layer of white plaster covering the basalt floor in Room E3C9, looking northwest.](#)

Later Remains. Area F revealed evidence of a later settlement: evidence of destruction was observed in the eastern part of the area; some of the rooms in the area were blocked with walls; and the floor made of basalt slabs in room E3C9 was covered with a layer of white plaster (Fig. 9).
